# SPATIAL ANALYSIS AND INTERVENTION STRATEGIES FOR SUSTAINABLE WATERSHED MANAGEMENT: A CASE STUDY OF MICRO WATERSHED 27K15G

Dilna K S

College of Agriculture, Ambalavayal, Kerala Agricultural University

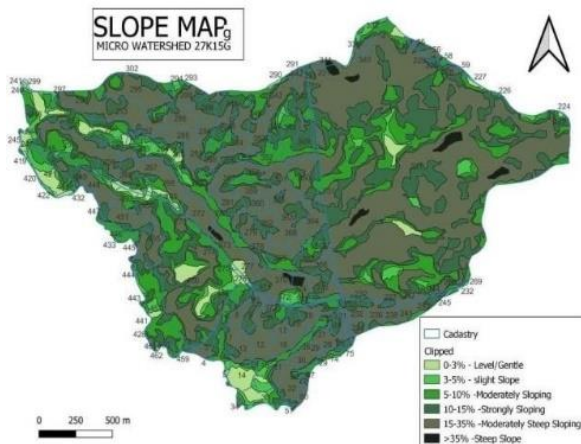
Figure 7- Slope map

**Slope Map:** The slope map classifies the watershed area based on the degree of slope, which is a crucial factor for planning interventions. For example, the map reveals that the largest portion of the watershed (49.96%) has a moderately steep slope ranging from 15-35%, while only a small area (0.72%) has a steep slope exceeding 35%.<sup>1</sup> These steep areas are particularly vulnerable to soil erosion and might necessitate interventions like terracing or agroforestry to stabilize the slopes and reduce runoff.

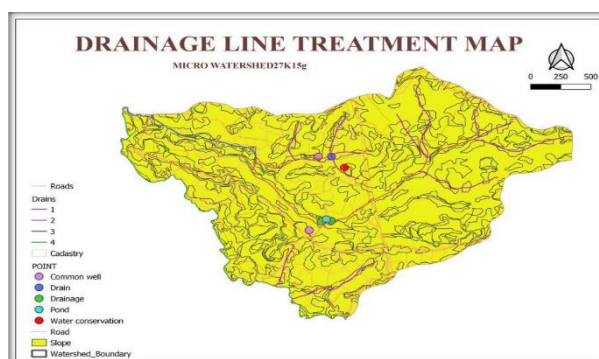
*Figure 9 – Drainage line treatment map*

Survey no	Soil	Slope	Existing land use	Problem	Interventions	Expected Outcome
352	Very fine soil	5-10%	Drain	Unprotected boundary	Maintenance and repair, boundary strengthening.	Reduced drain bank erosion, improved stability and longevity of drainage structures, and reduced maintenance costs.
278	Fine soil	0-3%	Drain	Heavy weed infestation, unprotected boundary and soil clogging	Weeding and cleaning, construction of side wall	Reduced gully erosion, decreased downstream sedimentation, improved water infiltration, and potential for restoring degraded land.
352	Very fine soil	5-10%	Common well	Algal infestation, torn net covering	Cleaning and provision of net cover	Improved water quality.

277	Very fine soil	15-35%	Common well	No proper covering, lack of rope adbucket for water collection.	Cleaning, provision of covering net and installation of solar panel motor	Improved water quality, reduced maintenance costs.
-----	----------------	--------	-------------	---	---	--
